# Sechrist Hyperbaric Technical Bulletin 008

## NOISY VENTILATION REGULATOR HB 305-05

All "H" Series Chambers  
Any Chamber with 'Captured Relief Valve Kit' installed

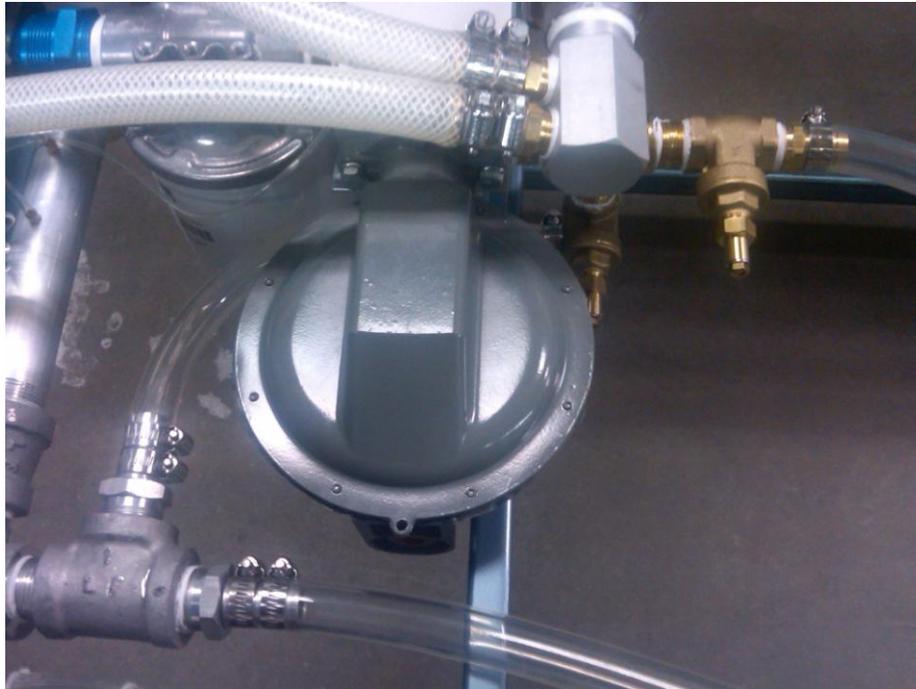
Photo A – Identification of the American regulator.

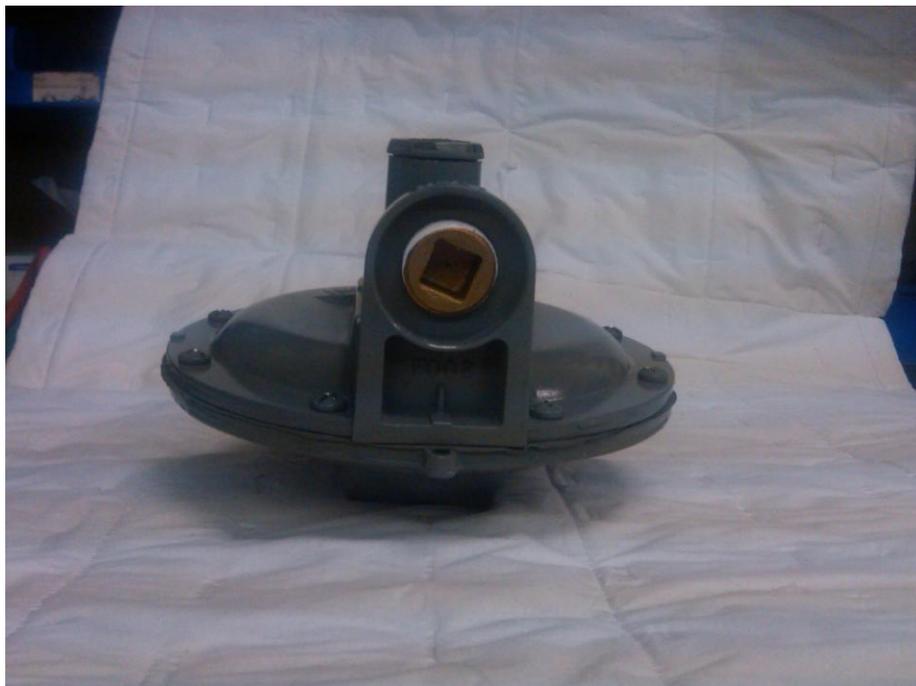
Photo B – Removal of the Vent Limiter with a 1/2 inch socket drive from the American regulator (entire regulator removed only for photo purposes, does not need to be entirely removed during swap of Limiters)

We are increasing the diameter of the orifice to 0.050 inch in all new production, IF you should encounter a chamber generating this noise, remove the current "Vent Limiter" (0.040) from the vent port and replace it with a new "Vent Limiter" 0.050, please note that the new one will also have a "**S**" engraved on the face of the limiter.
